Measurements

Profiles of the turbidity in the water column were taken at four locations. Due to the current, these are lines instead of points, starting south, drifting north.

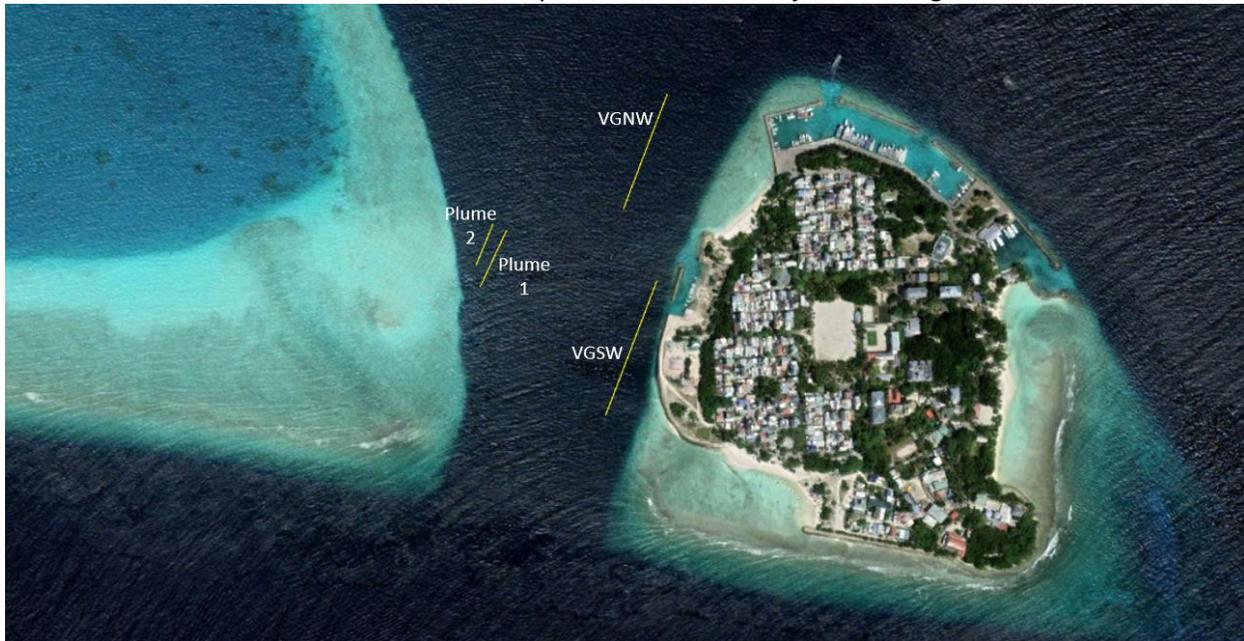
- The probe was lowered to the maximum cable length (30 m), where turbidity was measured for approximately a minute.
- The probe was then reeled in to halfway the maximum cable length, where turbidity was again measured for approximately a minute.
- The probe was then reeled in to approximately 1.5m depth to measure turbidity at the surface for approximately a minute.

The locations are as follows:

- Plume 1 – taken in the middle of the plume around 15:45, just before high tide
- VGNW – Villigili Northwest, referred to in the EIA as W15
- VGSW – Villigili Southwest
- Plume 2 – taken in the middle of the plume around 16:15, just after high tide

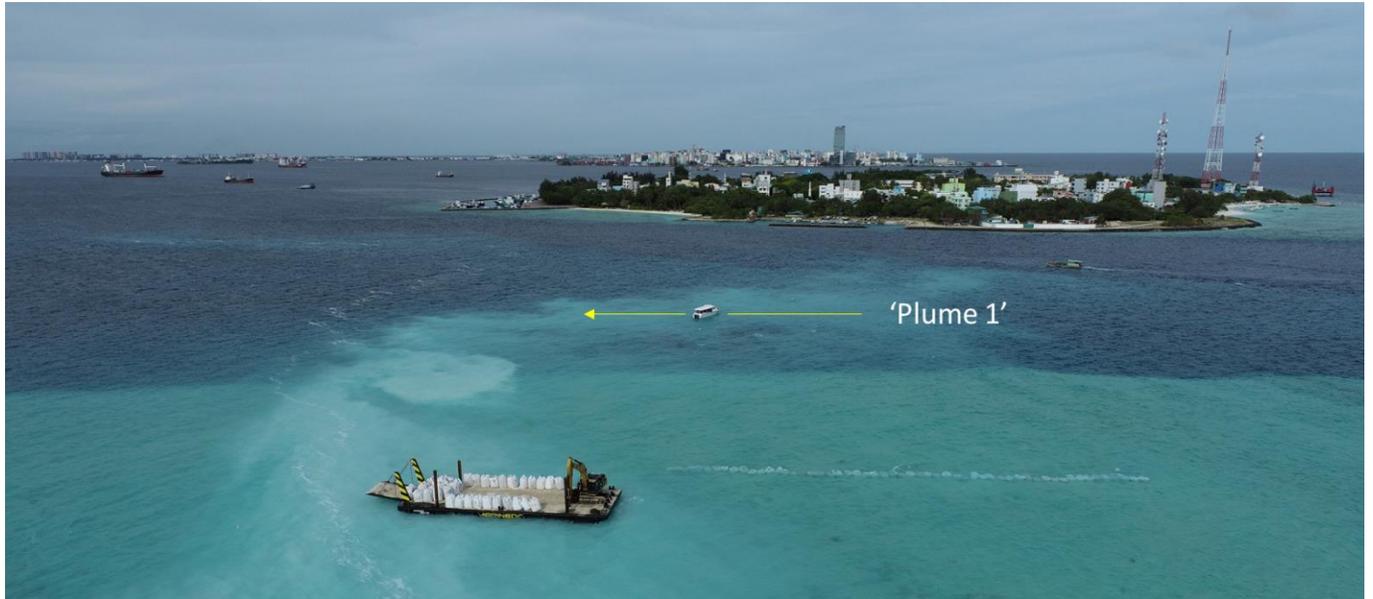
Below image was taken at 15:49, halfway during the measurement 'Plume 1'. The yellow arrow shows the path along which the boat drifted during the measurement. The image shows a clearly visible plume, but the above readings show that it is only superficial and turbidity values are quite low (5.4 NTU).

Both above pictures show Contractor constructing a row of big bags on the eastern side of Gulhifalhu reef. During low tide, these big bags contain turbidity over the entire water column, as the big bags then

reach above water. During high tide, the big bags contain the lower part of the turbidity plume. Big bag effectiveness will be further evaluated the coming days and extended if effective and necessary.

Furthermore, the pictures show the effectivity of halting backhoe operations before high tide and resuming only after high tide. On 27-05, Contractor halted backhoe operations approximately two hours before high tide and resumed work approximately half an hour after high tide.

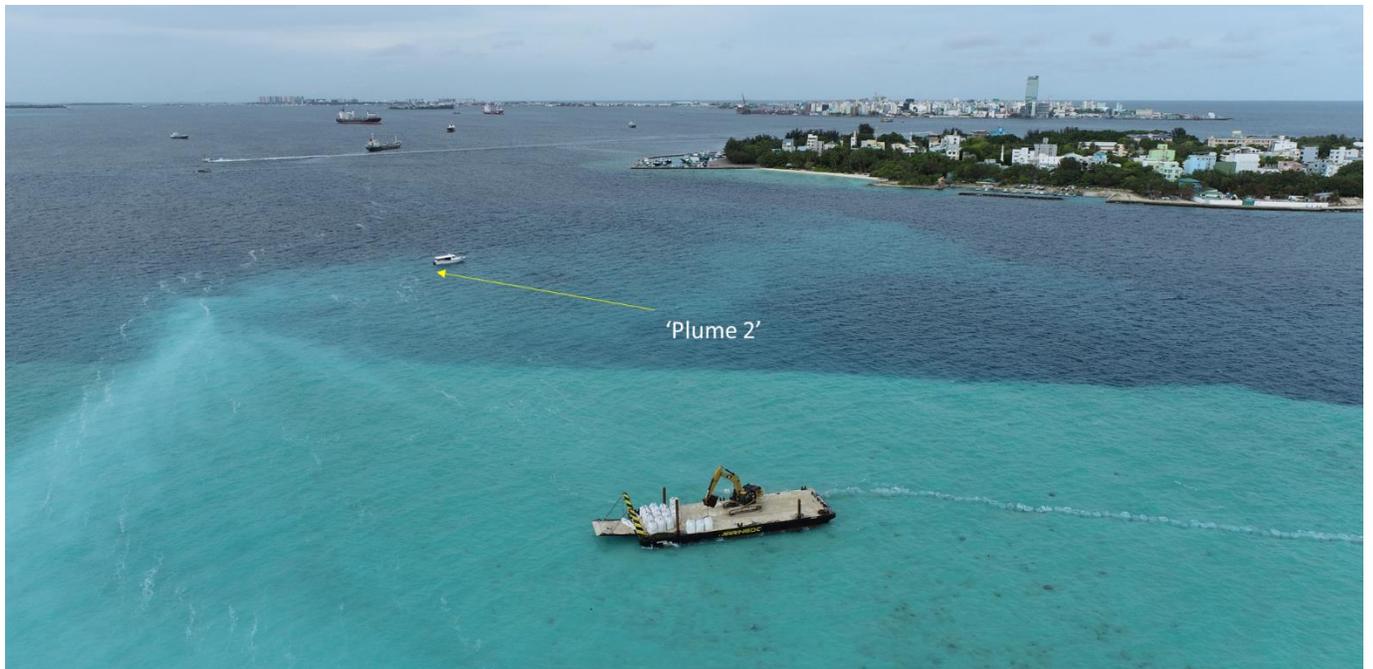
Below image was taken at 16:20, towards the end of measurement 'Plume 2'. The image clearly shows that the plume has decreased quickly after high tide (16:02).
